**Sub:** Publishing of Technical Bulletin in electronic form on the KPCL website

Details of activity : Problem solving by modification to phosphate dosing system of RTPS -Unit-5 boiler.

# PHOSPHATE DOSING SYSTEM

## 210MW - RTPS-U 5

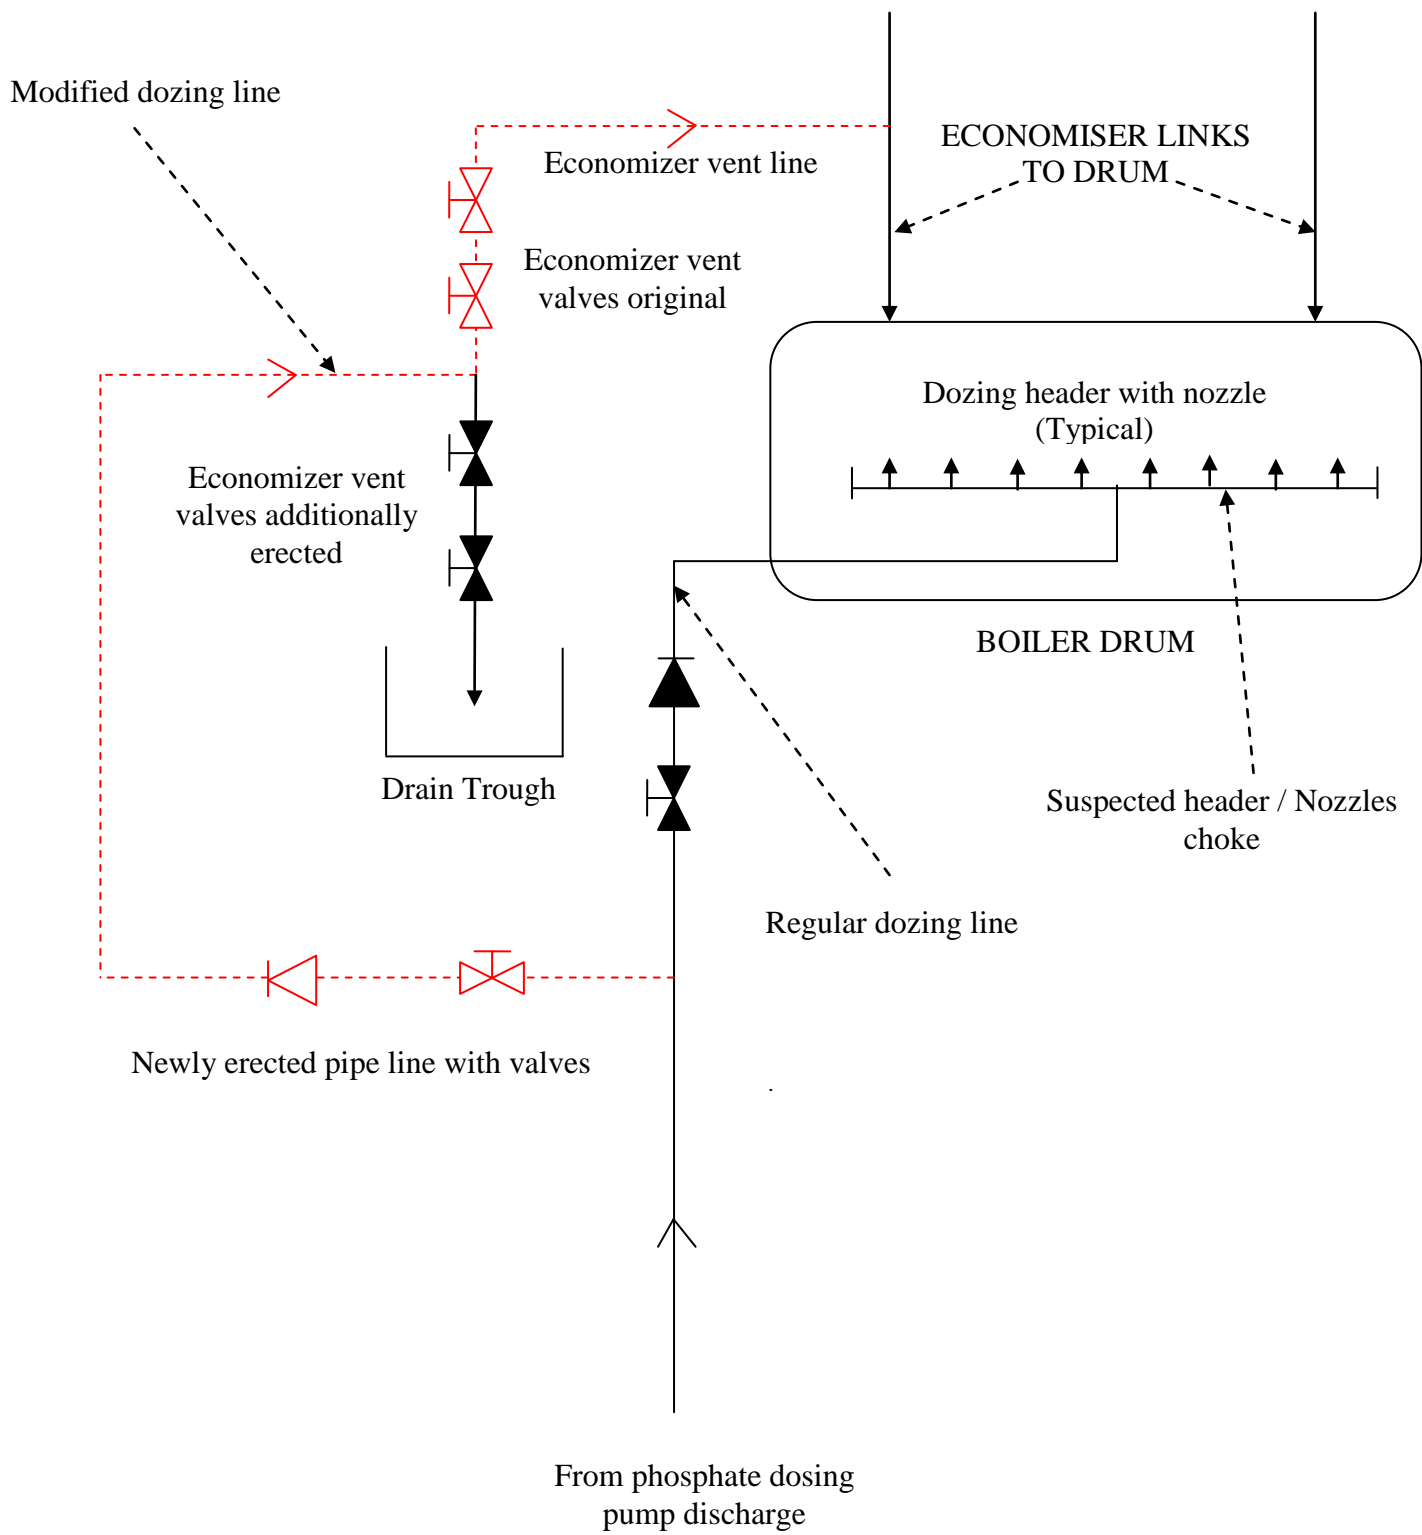
- As economizer vents could not be operated when boiler in running condition, two numbers of additional valves were installed in series to the with a TEE provision in between the existing set of valves & new set of valves.
- Separate line was laid with suitable pipe (higher thickness to cater highest pressure line in the boiler feed system) and one NRV (Non- return Valve) from the TEE in the economizer vent line & up to existing dozing line at the left side of the drum.
- The inlet valve near the boiler drum in the existing dozing line was kept closed
- The existing line was cut at suitable location & newly laid line was joined to the existing line with a TEE.

**Note:** Refer the FIGURE for detailed understanding of the modifications.

After thorough study of the feed system including economizer, it was preliminarily decided to explore the possibility of dozing phosphate into the feed system through economizer link pipe to drum. It was also decided to utilize the economizer vent line which is connected to the economizer link pipes from the top. For this purpose, suitable modification to the dozing line was necessary.

Accordingly the dozing line was modified as briefed below:
